MG / 288

## SERVICE MEMORANDUM cancelling MG/282

### REMEDIES FOR POSSIBLE COMPLAINTS

'MGA' TWIN CAM

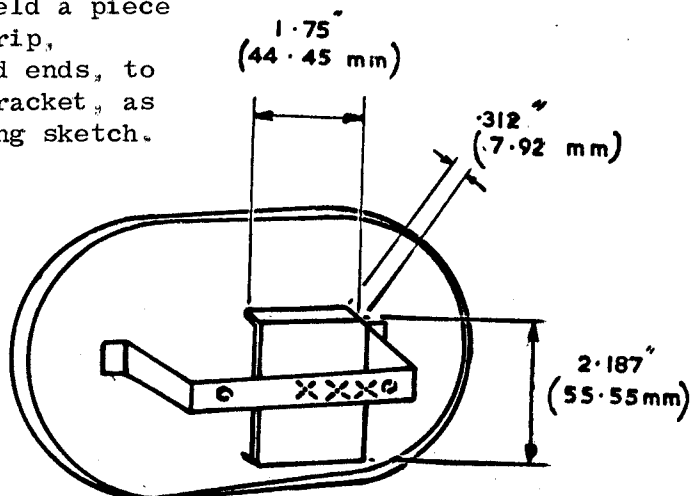
Air cleaners:

In the case of the first 28 cars it is possible for the elements in the air cleaners to move out of position and foul the carburettor inlet.

The remedy is to spot-weld a piece of .031" thick steel strip,  $1\frac{3}{4}$ " long and with turned ends, to the air cleaner inner bracket, as shown in the accompanying sketch.
