SCI builds an **MGA TWIN CAM** for competition *by John Christy*

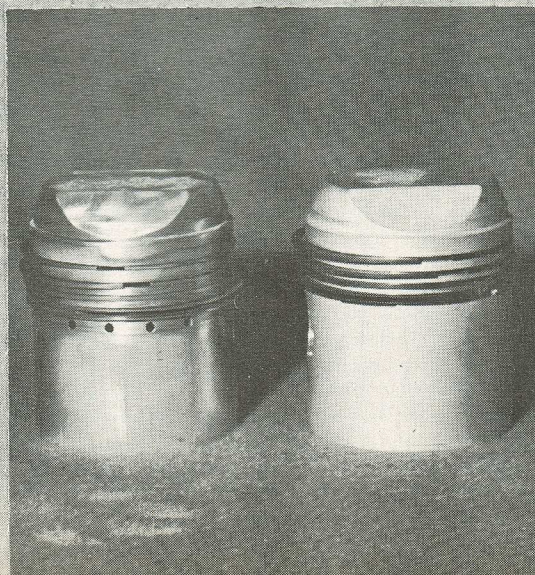
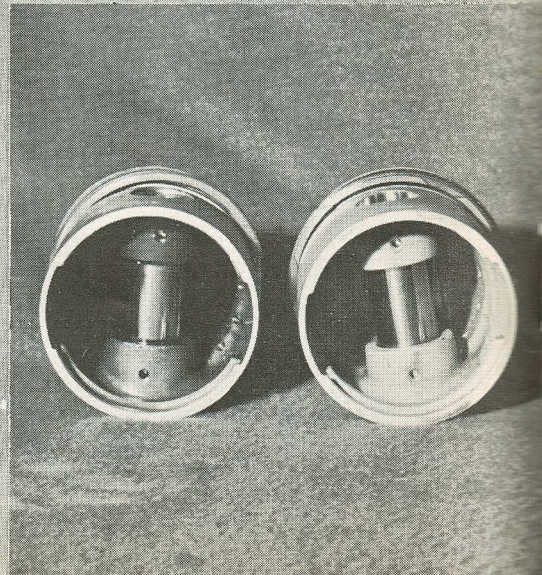
*LEFT — New type of piston is seen at right. Rings are closer together and there are no vent holes visible. In the SCI MG the top chrome ring was replaced with an iron ring similar to second and third units.
RIGHT — Pins are palm-push fit at room temperature. Large ridges visible can be cut for balance.*

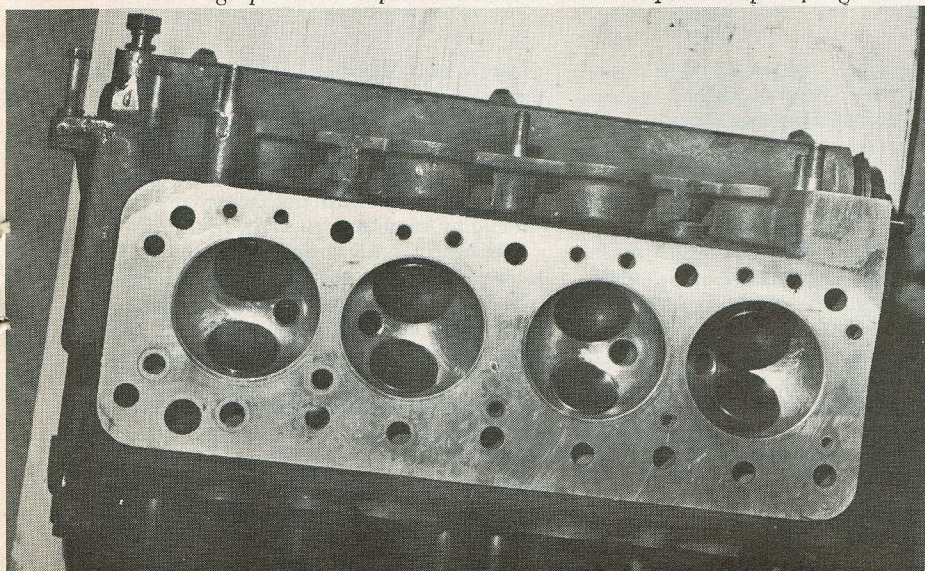
Combustion chambers were relieved of all sharp edges left in production machining operations. Special attention must be paid to sparkplug holes.

Other than the port matching and cleaning the major work in the head is the relief of hot spots in the form of sharp edges left by machining and doming operations. The major source of trouble and the one that probably caused the running-on and preignition in our engine was the sparkplug area. Apparently the dome cutting was done after the plug inlet was drilled and threaded and the resulting knife edges made ideal glow points. Such faults as these are not necessarily the private property of MG Twin Cams but are found in many other marques as well and cause much of the running-on character that is usually associated with four cylinder engines tending to cause the mistaken impression that running on and preignition is one of the characteristics of the four-barrel. All such edges and the edges of the combustion chamber as well were rounded off in our Twin Cam. Where it once dinged, pinged and chugged on with the switch off it now runs smoothly and quietly under load and shuts off instantly with the key. Combustion now takes place when the sparkplug tells it to and not when the fuel and air are shoved up against some evilly glowing piece of metal.

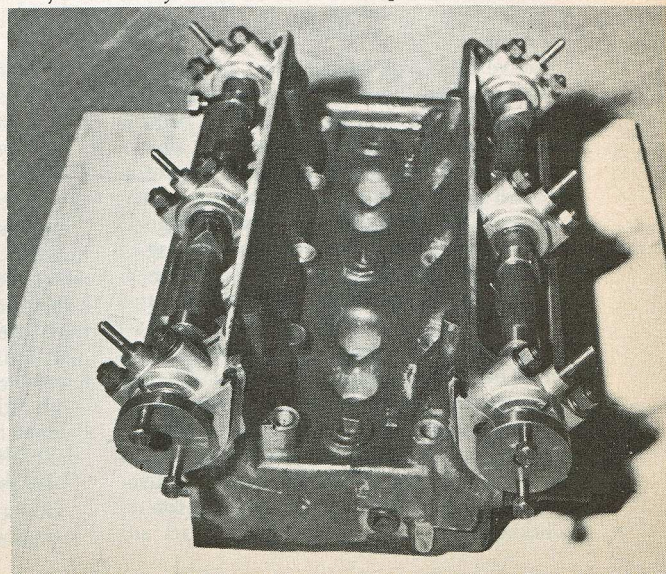
Head assembly from the front shows the straight-forward layout. Cams are clamped in 3 bearings.

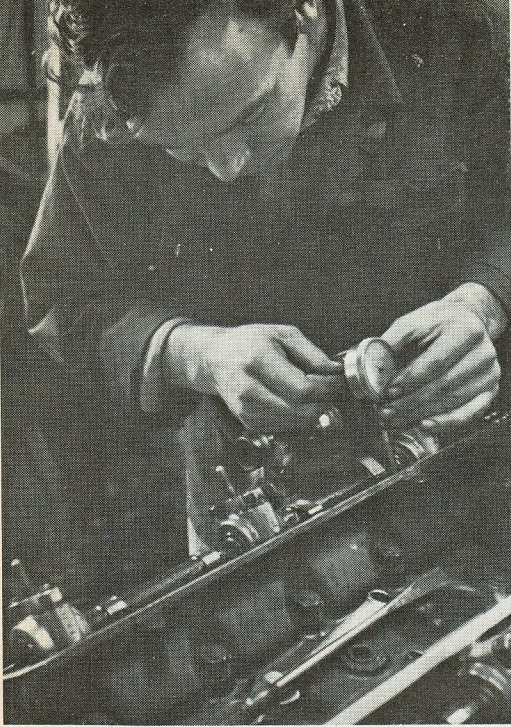
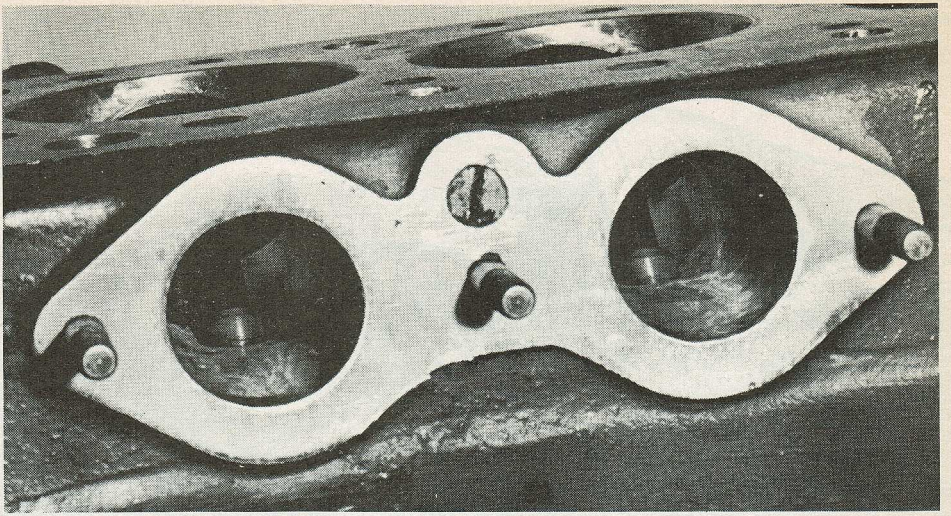
one valve to .021 on another and all points in between for the rest. The cam timing also gave a clue to why we hadn't been getting the power we had expected. The intake cam checked out at four degrees late and the exhaust cam proved to be seven degrees early. In other words the intake valves were opening and closing later in the cycle and the exhaust valves were operating much too soon. The net result was that most of the fire was going out the exhaust instead of pushing the pistons down like it should.

LEFT — Joe Virag checks out the valves with a dial indicator prior to disassembly of the engine. All timing was carefully checked during dismantling and assembly. ABOVE — Ports on exhaust side are huge and virtually straight through. No enlargement necessary but all ports were matched to manifolds and equalized in size.

Lesson number two. If you have one of the early series Twin Cam units and are not getting the wallop you should, set the cams by use of a degree wheel and depending on the camshaft numbers use the following figures:

Intake opens 20 degrees BTDC
 Intake closes 50 degrees ABDC
 Exhaust opens 50 degrees BBDC
 Exhaust closes 20 degrees ATDC

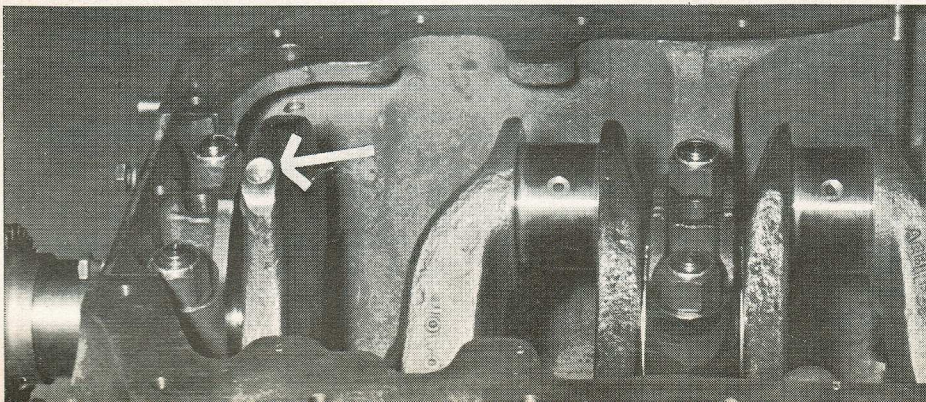
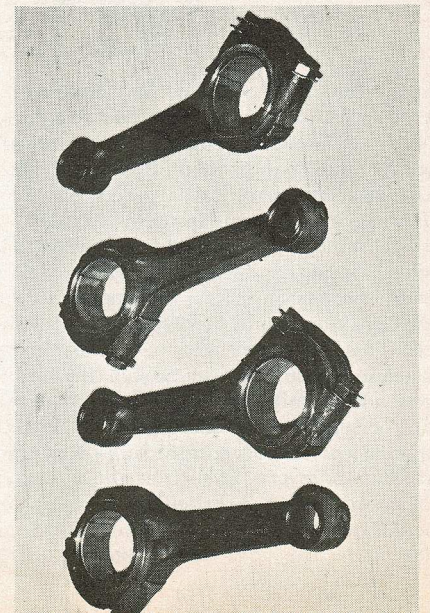
BELOW — Dynamic balance tests of the sturdy crankshaft showed only one small balance drilling was needed (arrow). The same applied to flywheel and clutch. RIGHT — Short stiff rods are similar to those in Stage 4 MGA fitted with solid skirt pistons. Large bosses on caps and little end may be ground for balance.

Each rod, piston and the bearings to go with that particular rod were carefully weighed and balanced against each other. The weights were marked down and the crank, flywheel and new clutch assembly were sent out for dynamic balancing. Only one small balance hole had to be drilled in each item but they *did* need the drilling. This balancing comes easy on the Twin Cam — or any MGA for that matter. The rods have large, meaty sections at the lower end of the caps and on the little ends so they can be slightly ground to gain the necessary end-for-end and overall balance. The pistons also have internal ridges at the bottom of the skirts from which metal can be carved if found necessary. In all cases it is vital that the bearings to be used in the final assembly be clamped in the rods when the weighing is done. It is also a good idea at this point to tamp the locating tang on each bearing shell into its recess in the rod big-end. These are *not* full floating bearings and must be well and securely located. The rods in the Twin Cam are virtually the same as the Stage Four rods for the MGA in that the wrist pins are of the full floating, push-fit type rather than the clamped pins found in the standard MGA and other B-Type engine units. These wrist-pins should be (and were in our case) an easy palm-push fit in both the rod and the piston at about 70 degree temperature, Fahrenheit. Location is by circlips in the piston at either end of the pin.
