SCI builds an **MGA TWIN CAM** for competition *by John Christy*

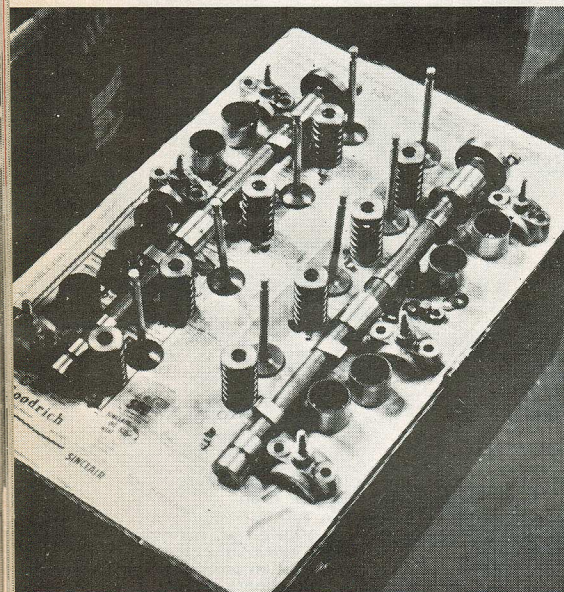
Valve, cam assembly broken down and laid out with all components separated.

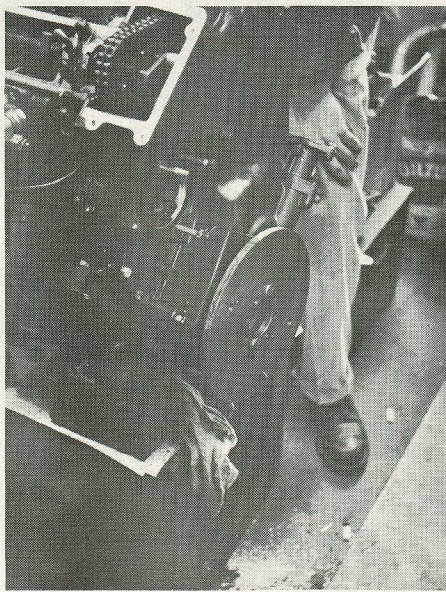
A degree wheel is a must if accurate valve timing is to be achieved on MG.

Lesson number two. If you have one of the early series Twin Cam units and are not getting the wallop you should, set the cams by use of a degree wheel and depending on the camshaft numbers use the following figures:

Intake opens 20 degrees BTDC
 Intake closes 50 degrees ABDC
 Exhaust opens 50 degrees BBDC
 Exhaust closes 20 degrees ATDC

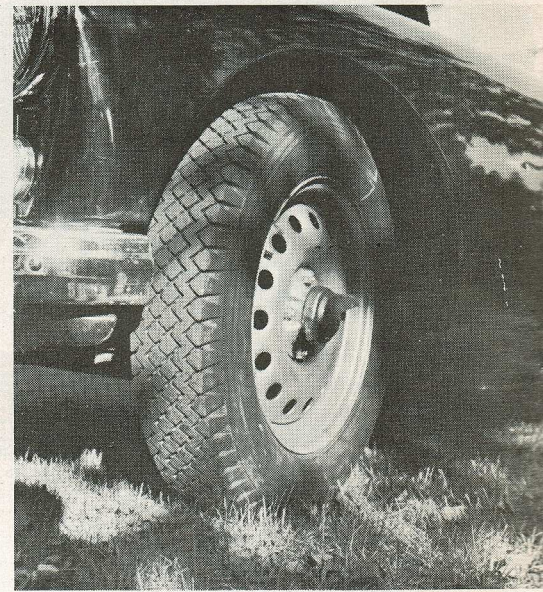
Dunlop racing tires accounted for almost a full second lap-time in tests.
